MILITARY AIRCRAFT ACCIDENT SUMMARY
OF RAF BOARD OF INQUIRY

Aircraft: Tornado GR1A ZA397
Date of Accident: 1 August 1994
Place of Accident: 20 nm east of
La Grande Rivière, Canada .
Casualties: 2 minor

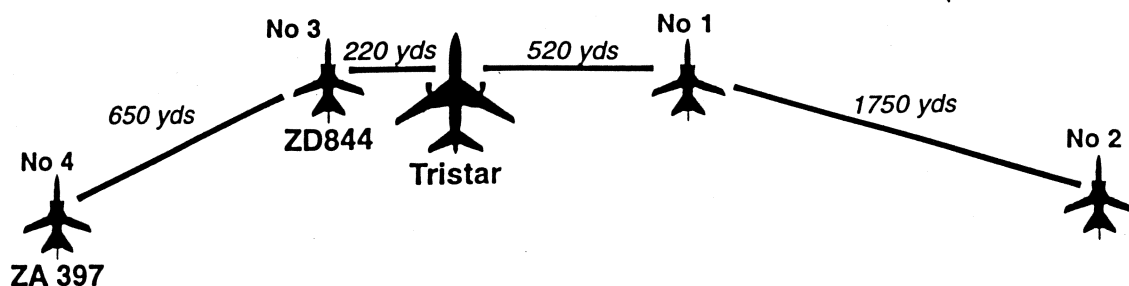
3. Some 5½ hours into the flight, all three air-to-air refuelling rendezvous had been completed successfully and the four Tornados were flying in loose formation with the Tristar aircraft (shown in the diagram below) as they approached the turning point at La Grande Rivière. ZD844 and ZA397 were

occupying the Nos 3 and 4 positions respectively. The weather was excellent with clear horizon. At the turning point, the Tristar began a gentle turn to the left, its pilot transmitting a message that the aircraft was to roll out "on heading 095"; he did not indicate, however, whether this heading was to be True or Magnetic, and rolled out on a heading of 093° Magnetic. The Tornados, which invariably fly with reference to True headings, all rolled out closer to 093° True and, because of magnetic variation, the two Tornados on the left of the formation began to converge with the Tristar. The pilot of ZD844, however, realising that the Tristar had not yet completed its turn, made a series of port turns in order to maintain separation. His attention was then drawn to a minor problem with the aircraft's autopilot, which he tried to resolve with the assistance of his navigator. Meanwhile, the pilot of ZA397, having initially checked that his aircraft was not converging with ZD844, looked into the cockpit to examine maps and diversion tables. His navigator then drew his attention to some ground features that he had noticed during the turn. The navigator suddenly became aware of the close proximity of ZD844 and shouted a warning to his pilot, who immediately rolled the aircraft to the left. In spite of this,
